Wadebridge School

ASBESTOS MANAGEMENT POLICY September 2024

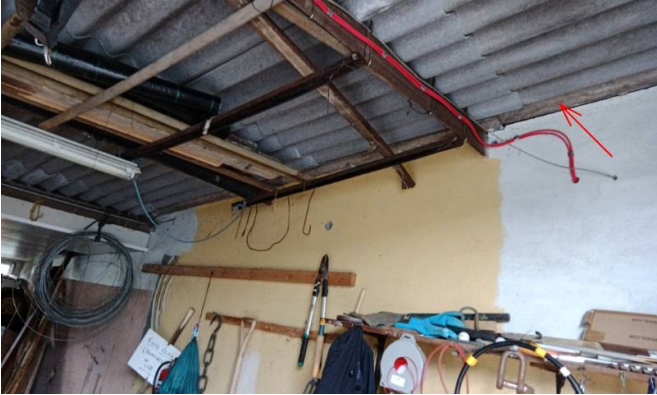
Sample Ref. No:	AS AD001175*
	Material Location:	AC Corrugated Roof Sheet against wall to P.E Base 001
	Approx. Quantity:	10lm
	Accessibility:	Occasionally likely to be disturbed
	Comments:	Manageable condition. Do not disturb and remove if affected by any proposed refurbishment works or if proven to be damaged.
	Sample Notes:	
Re-inspection notes:	Asbestos Yearly Re-inspection 24/25: 29/07/2024	
Recommendation:	No Attention Required (Inspect at intervals) – Good/reasonable condition and adequately surface treated	
Material Assessment Score (MAS)		Score
Product Type:	Asbestos Cement	1
Condition:	Low Damage	1
Treatment:	Unsealed	1
Asbestos Type:	Chrysotile	1
Total:		4
Priority Assessment Score (PAS)		
Normal Occupant Activity Likelihood of Disturbance	Low disturbance	1
Location	Rooms up to 100m ²	2
Accessibility	Occasionally likely to be disturbed	1
Extent/Amount	<10m ² or <10m pipe run	1
Average Score		2

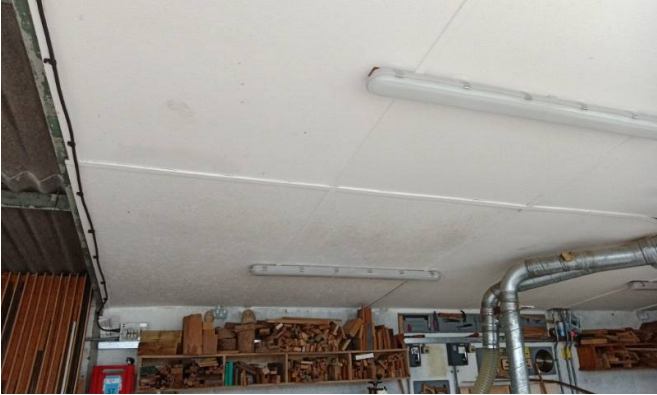
Sample Ref. No:	AS AD001175*
	Material Location:	AC Corrugated Roof above fixed fibreboard ceiling
	Approx. Quantity:	40m ²
	Accessibility:	Usually inaccessible or unlikely to be disturbed
	Comments:	Not visible within shop. Unable to inspect
	Sample Notes:	
Re-inspection notes:	Asbestos Yearly Re-inspection 24/25: 29/07/2024	
Recommendation:	No Attention Required (Inspect at intervals) – Good/reasonable condition and adequately surface treated	
Material Assessment Score (MAS)		Score
Product Type:	Asbestos Cement	1
Condition:	Low Damage	1
Treatment:	Unsealed	1
Asbestos Type:	Chrysotile	1
Total:		4
Priority Assessment Score (PAS)		
Normal Occupant Activity Likelihood of Disturbance	Low disturbance	1
Location	Rooms up to 100m ²	2
Accessibility	Usually inaccessible or unlikely to be disturbed	0
Extent/Amount	10m ² - 50m ² or 10m - 50m pipe run	2
Average Score		2
Human Exposure Potential		
Number of Occupants	4 to 10	2

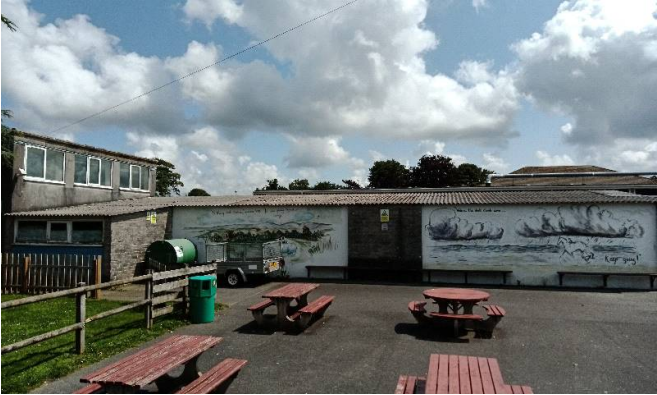
Sample Ref. No:	AD001175*
	Material Location:	AC Corrugated Roof above Machine Shop (004) only
	Approx. Quantity:	40m ²
	Accessibility:	Occasionally likely to be disturbed
	Comments:	Same as 4141/4/0/005/19 - 2003 Survey Report. Do not disturb. Remove if affected by any proposed refurbishment works or if proven to be damaged.
	Sample Notes:	
Re-inspection notes:	Asbestos Yearly Re-inspection 24/25: 29/07/2024	
Recommendation:	No Attention Required (Inspect at intervals) – Good/reasonable condition and adequately surface treated	
Material Assessment Score (MAS)		Score
Product Type:	Asbestos Cement	1
Condition:	Low Damage	1
Treatment:	Unsealed	1
Asbestos Type:	Chrysotile	1
Total:		4
Priority Assessment Score (PAS)		
Normal Occupant Activity Likelihood of Disturbance	Low disturbance	1
Location	External	0
Accessibility	Occasionally likely to be disturbed	1
Extent/Amount	10m ² - 50m ² or 10m - 50m pipe run	2

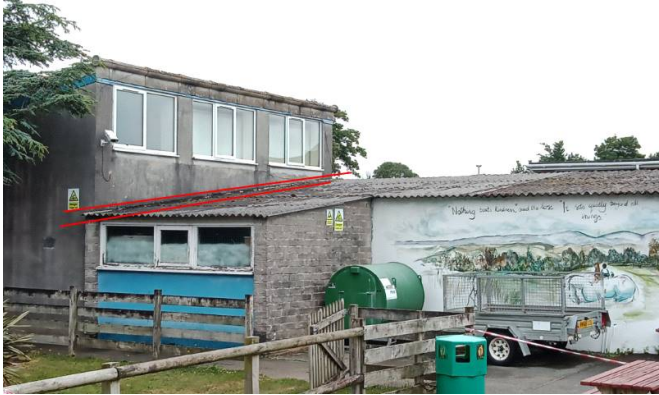
Sample Ref. No:	AS AD001175*
	Material Location:	AC Corrugated Roof next to wall of PE Dept
	Approx. Quantity:	4.5m
	Accessibility:	Occasionally likely to be disturbed
	Comments:	Narrow section of asbestos cement. Do not disturb. Remove if affected by any proposed refurbishment works or if proven to be damaged.
	Sample Notes:	
Re-inspection notes:	Asbestos Yearly Re-inspection 24/25: 29/07/2024	
Recommendation:	No Attention Required (Inspect at intervals) – Good/reasonable condition and adequately surface treated	
Material Assessment Score (MAS)		Score
Product Type:	Asbestos Cement	1
Condition:	Low Damage	1
Treatment:	Unsealed	1
Asbestos Type:	Chrysotile	1
Total:		4
Priority Assessment Score (PAS)		
Normal Occupant Activity Likelihood of Disturbance	Low disturbance	1
Location	External	0
Accessibility	Occasionally likely to be disturbed	1
Extent/Amount	<10m ² or <10m pipe run	1
Average Score		1
Human Exposure Potential

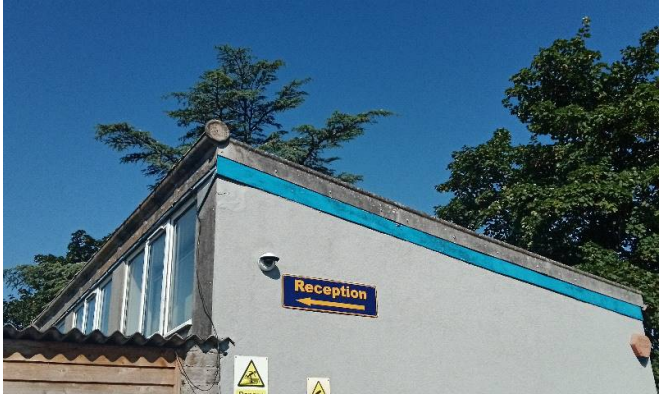
Sample Ref. No:	Presumed
	Material Location:	Molded Cement Ridge & Fascia Panels
	Approx. Quantity:	18m
	Accessibility:	Usually inaccessible or unlikely to be disturbed
	Comments:	Presumed to contain asbestos until proven otherwise. Sampling exercise recommended prior to any disturbance. Monitor
	Sample Notes:	
Re-inspection notes:	Asbestos Yearly Re-inspection 24/25: 29/07/2024	
Recommendation:	No Attention Required (Inspect at intervals) – Good/reasonable condition and adequately surface treated	
Material Assessment Score (MAS)		Score
Product Type:	Asbestos Cement	1
Condition:	Low Damage	1
Treatment:	Unsealed	1
Asbestos Type:	Crocidolite (or unknown)	3
Total:		6
Priority Assessment Score (PAS)		
Normal Occupant Activity Likelihood of Disturbance	Rare disturbance	0
Location	External	0
Accessibility	Usually inaccessible or unlikely to be disturbed	0
Extent/Amount	10m ² - 50m ² or 10m - 50m pipe run	2

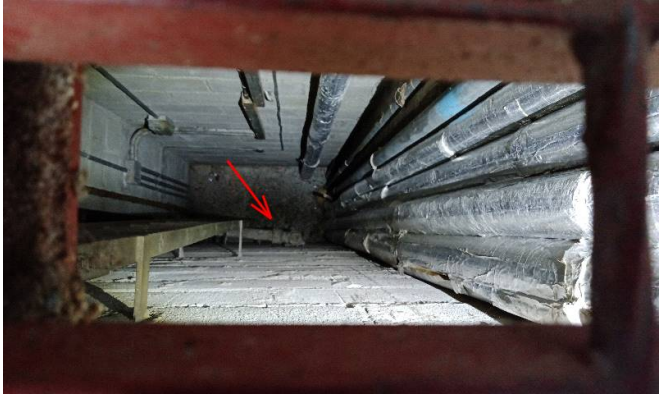
Sample Ref. No:	Presumed
	Material Location:	Presumed Cement Flue Pipe at the bottom of Chimney Brest
	Approx. Quantity:	Unknown
	Accessibility:	Usually inaccessible or unlikely to be disturbed
	Comments:	Visually seen through 2nd floor riser (Circ 2/001A) Suspected material only. Monitor condition. Remove if affected by proposed refurbishment works.
	Sample Notes:	
Re-inspection notes:	Asbestos Yearly Re-inspection 24/25: 29/07/2024	
Recommendation:	No Attention Required (Inspect at intervals) – Good/reasonable condition and adequately surface treated	
Material Assessment Score (MAS)		Score
Product Type:	Asbestos Cement	1
Condition:	Low Damage	1
Treatment:	Unsealed	1
Asbestos Type:	Crocidolite (or unknown)	3
Total:		6
Priority Assessment Score (PAS)		
Normal Occupant Activity Likelihood of Disturbance	Rare disturbance	0
Location	Confined spaces	3
Accessibility	Usually inaccessible or unlikely to be disturbed	0

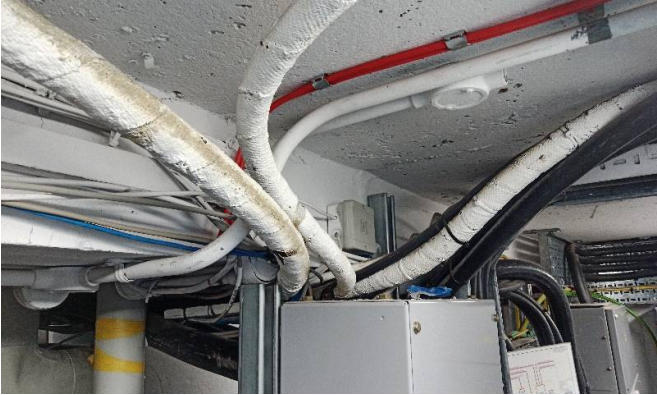
Sample Ref. No:	Presumed
	Material Location:	Woven Cable Wrap impregnated with Bitumen
	Approx. Quantity:	10lm
	Accessibility:	Occasionally likely to be disturbed
	Comments:	Encapsulated with white paint. Monitor condition. Remove if affected by proposed refurbishment works.
	Sample Notes:	
Re-inspection notes:	Asbestos Yearly Re-inspection 24/25: 29/07/2024	
Recommendation:	No Attention Required (Inspect at intervals) – Good/reasonable condition and adequately surface treated	
Material Assessment Score (MAS)		Score
Product Type:	Textile	2
Condition:	Low Damage	1
Treatment:	Composite Material	0
Asbestos Type:	Chrysotile	1
Total:		4
Priority Assessment Score (PAS)		
Normal Occupant Activity Likelihood of Disturbance	Rare disturbance	0
Location	Rooms up to 100m ²	2
Accessibility	Occasionally likely to be disturbed	1
Extent/Amount	<10m ² or <10m pipe run	1
Average Score		2
Human Exposure Potential		
Number of Occupants	1 to 3	1

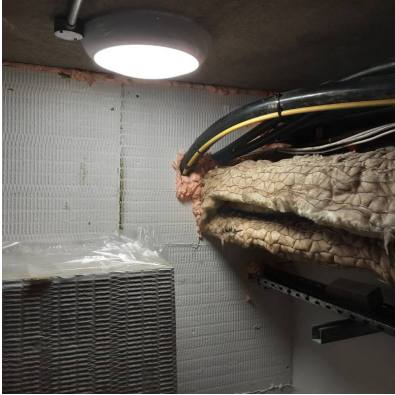
Sample Ref. No:	4153/1/-1/004/15 (TPS000085)*
	Material Location:	Asbestos Paper Debris to Pipework
	Approx. Quantity:	<1m ²
	Accessibility:	Usually inaccessible or unlikely to be disturbed
	Comments:	Area now completely shutted. ACM presumed still present. Remove using A Licensed Contractor upon Demolition or Major Refurbishment.
	Sample Notes:	
Re-inspection notes:	Asbestos Yearly Re-inspection 23-24: 25/07/2023	
Recommendation:	Removal Required Prior to Work	
Material Assessment Score (MAS)		Score
Product Type:	Asbestos Textiles/Paper	2
Condition:	High Damage	3
Treatment:	Unsealed	2
Asbestos Type:	Chrysotile	1
Total:		8
Priority Assessment Score (PAS)		
Normal Occupant Activity	Rare disturbance	0
Likelihood of Disturbance		
Location	Confined spaces	3
Accessibility	Usually inaccessible or unlikely to be disturbed	0
Extent/Amount	<10m ² or <10m pipe run	1
Average Score		2
Human Exposure Potential

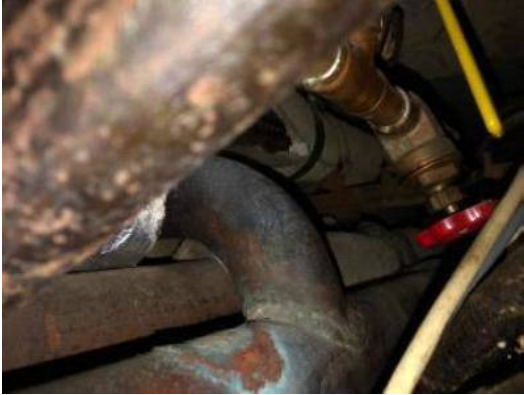
Sample Ref. No:	AS 4153/1/-1/004/15 {TPS000085}*
	Material Location:	Asbestos Paper Lining to Pipework
	Approx. Quantity:	20lm
	Accessibility:	Usually inaccessible or unlikely to be disturbed
	Comments:	Presumed to contain asbestos until otherwise proven. Area now completely shutted. ACM presumed still present behind new MMMF wall. Remove using A Licensed Contractor upon Demolition or Major Refurbishment.
	Sample Notes:	
Re-inspection notes:	Asbestos Yearly Re-inspection 24/25: 29/07/2024	
Recommendation:	Removal Required Prior to Work	
Material Assessment Score (MAS)		Score
Product Type:	Asbestos Textiles/Paper	2
Condition:	Low Damage	1
Treatment:	Unsealed	2
Asbestos Type:	Chrysotile	1
Total:		6
Priority Assessment Score (PAS)		
Normal Occupant Activity	Rare disturbance	0
Likelihood of Disturbance		
Location	Confined spaces	3
Accessibility	Usually inaccessible or unlikely to be disturbed	0
Extent/Amount	10m ² - 50m ² or 10m - 50m pipe run	2

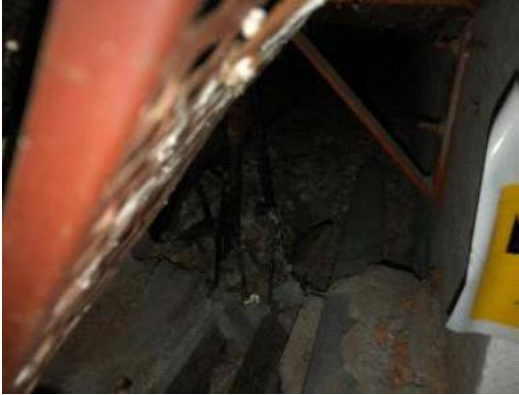
Sample Ref. No:	Presumed
	Material Location:	Loose Vermiculite Insulation on Floor of Pipe Duct
	Approx. Quantity:	10m ²
	Accessibility:	Usually inaccessible or unlikely to be disturbed
	Comments:	Presumed to contain asbestos until otherwise proven. Area now completely shutted behind new MMMF wall. ACM presumed still present. Remove using A Licensed Contractor upon Demolition or Major Refurbishment.
	Sample Notes:	
Re-inspection notes:	Asbestos Yearly Re-inspection 23-24: 25/07/2023	
Recommendation:	Removal Required Prior to Work	
Material Assessment Score (MAS)		Score
Product Type:	Asbestos Insulation	3
Condition:	High Damage	3
Treatment:	Unsealed	3
Asbestos Type:	Crocidolite (or unknown)	3
Total:		12
Priority Assessment Score (PAS)		
Normal Occupant Activity	Rare disturbance	0
Likelihood of Disturbance		
Location	Confined spaces	3
Accessibility	Usually inaccessible or unlikely to be disturbed	0

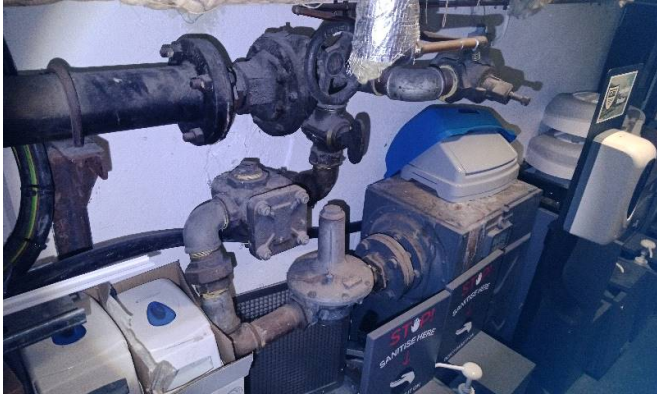
Sample Ref. No:	Presumed
	Material Location:	Gaskets to Pipework
	Approx. Quantity:	Small amounts
	Accessibility:	Easily disturbed
	Comments:	Visual inspection to pipework gaskets. Presumed to contain asbestos until otherwise proven. Gaskets edges slightly damaged. Surveyor recommends encapsulation. Remove if affected by any proposed refurbishment work
	Sample Notes:	
Re-inspection notes:	Asbestos Yearly Re-inspection 24/25: 29/07/2024	
Recommendation:	Repair or Remove – Some damage present and/or vulnerable to further damage, but not causing an immediate hazard. Encapsulation or removal is strongly recommended.	
Material Assessment Score (MAS)		Score
Product Type:	Gasket	2
Condition:	Low Damage	1
Treatment:	Unsealed	1
Asbestos Type:	Chrysotile	1
Total:		5
Priority Assessment Score (PAS)		
Normal Occupant Activity	Rare disturbance	0
Likelihood of Disturbance		
Location	Rooms up to 100m ²	2
Accessibility	Easily disturbed	2

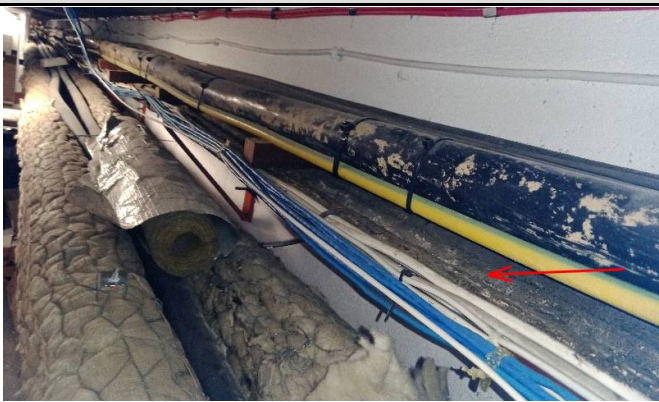
Sample Ref. No:	Presumed
	Material Location:	Woven Cable Wrap impregnated with Bitumen
	Approx. Quantity:	110lm
	Accessibility:	Occasionally likely to be disturbed
	Comments:	Visual inspection to woven cable wrap along the circulation. Presumed to contain asbestos until otherwise proven. Do not disturb.
	Sample Notes:	
Re-inspection notes:	Asbestos Yearly Re-inspection 24/25: 29/07/2024	
Recommendation:	No Attention Required (Inspect at intervals) – Good/reasonable condition and adequately surface treated	
Material Assessment Score (MAS)		Score
Product Type:	Textile	2
Condition:	Low Damage	1
Treatment:	Composite Material	0
Asbestos Type:	Chrysotile	1
Total:		4
Priority Assessment Score (PAS)		
Normal Occupant Activity Likelihood of Disturbance	Rare disturbance	0
Location	Rooms up to 100m ²	2
Accessibility	Occasionally likely to be disturbed	1
Extent/Amount	>50m ² or >50m pipe run	3
Average Score		2

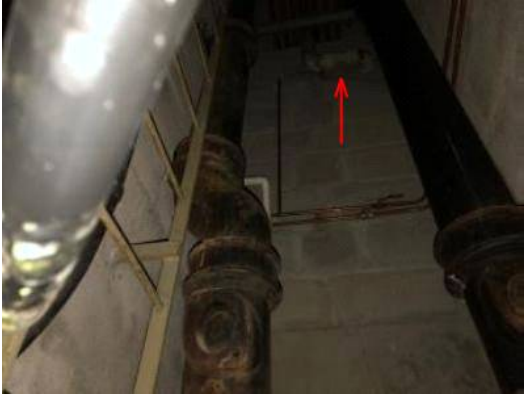
Sample Ref. No:	Presumed
	Material Location:	AC Flue Pipe within Service Void (Riser)
	Approx. Quantity:	7m to 1st Floor
	Accessibility:	Usually inaccessible or unlikely to be disturbed
	Comments:	Presumed to contain asbestos until otherwise proven. Area now completely shutted with new MMMF wall. ACM presumed still present. AC pipe runs up to the 1st and 2nd floor (visible from the service shaft). Do not disturb. Remove if affected by any proposed refurbishment works or if proven to be damaged.
	Sample Notes:	
Re-inspection notes:	Asbestos Yearly Re-inspection 24/25: 29/07/2024	
Recommendation:	No Attention Required (Inspect at intervals) – Good/reasonable condition and adequately surface treated	
Material Assessment Score (MAS)		Score
Product Type:	Asbestos Cement	1
Condition:	Low Damage	1
Treatment:	Unsealed	1
Asbestos Type:	Crocidolite (or unknown)	3
Total:		6
Priority Assessment Score (PAS)

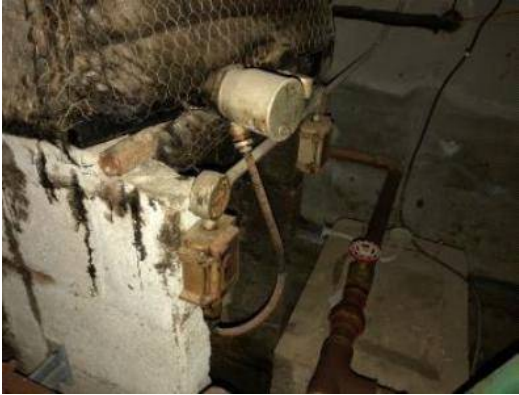
Sample Ref. No:	Inaccessible
	Material Location:	Suspected asbestos within switchgear to oil tank
	Approx. Quantity:	2no.
	Accessibility:	N/A
	Comments:	Not accessed as door locked and no key available. Visual inspection of electrical switchgear to redundant header tank adjacent oil storage tank. Presumed to contain asbestos until otherwise proven upon removal of tank. Exercise Caution & Inspect prior to any disturbance.
Sample Notes:		
Re-inspection notes:	Asbestos Yearly Re-inspection 24/25: 29/07/2024	
Recommendation:	Inspection Required Prior to Disturbance – Appointed contractors carrying out routine maintenance work should be made aware that these areas were inaccessible at the time of the survey and that further investigation is required prior to disturbance of the material.	
Material Assessment Score (MAS)		Score
Product Type:	N/A	N/A
Condition:	N/A	N/A
Treatment:	N/A	N/A
Asbestos Type:	N/A	N/A

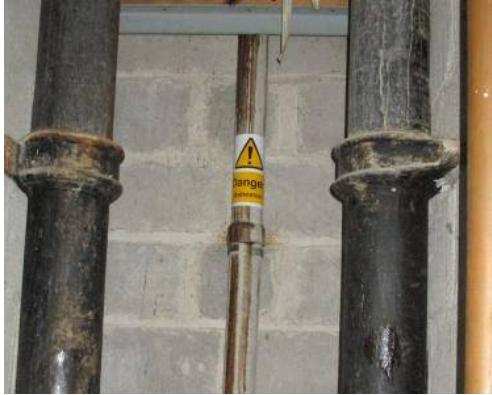
Sample Ref. No:	Presumed
	Material Location:	Cement Vent Pipe within Service Void
	Approx. Quantity:	10lm
	Accessibility:	Occasionally likely to be disturbed
	Comments:	to full height of block. Monitor condition. Remove if affected by proposed refurbishment works.
	Sample Notes:	
Re-inspection notes:	Asbestos Yearly Re-inspection 24/25: 29/07/2024	
Recommendation:	No Attention Required (Inspect at intervals) – Good/reasonable condition and adequately surface treated	
Material Assessment Score (MAS)		Score
Product Type:	Asbestos Cement	1
Condition:	Low Damage	1
Treatment:	Unsealed	1
Asbestos Type:	Crocidolite (or unknown)	3
Total:		6
Priority Assessment Score (PAS)		
Normal Occupant Activity Likelihood of Disturbance	Rare disturbance	0
Location	Confined spaces	3
Accessibility	Occasionally likely to be disturbed	1
Extent/Amount	<10m ² or <10m pipe run	1
Average Score		2
Human Exposure Potential		
Number of Occupants	None	0

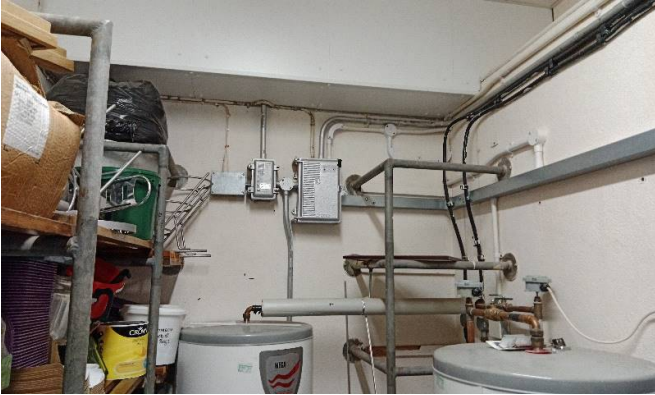
Sample Ref. No:	Presumed
	Material Location:	Gaskets/Backings/Flashguards within Electrical Switchgear
	Approx. Quantity:	2no.
	Accessibility:	Usually inaccessible or unlikely to be disturbed
	Comments:	Presumed to contain asbestos until proven otherwise. Do not disturb. Remove if affected by any proposed refurbishment work or proven to be damaged.
	Sample Notes:	
Re-inspection notes:	Asbestos Yearly Re-inspection 24/25: 29/07/2024	
Recommendation:	No Attention Required (Inspect at intervals) – Good/reasonable condition and adequately surface treated	
Material Assessment Score (MAS)		Score
Product Type:	Flash Guards	2
Condition:	Low Damage	1
Treatment:	Sealed	2
Asbestos Type:	Chrysotile	1
Total:		6
Priority Assessment Score (PAS)		
Normal Occupant Activity Likelihood of Disturbance	Rare disturbance	0
Location	Rooms up to 100m ²	2
Accessibility	Usually inaccessible or unlikely to be disturbed	0
Extent/Amount	Small amounts or items	0

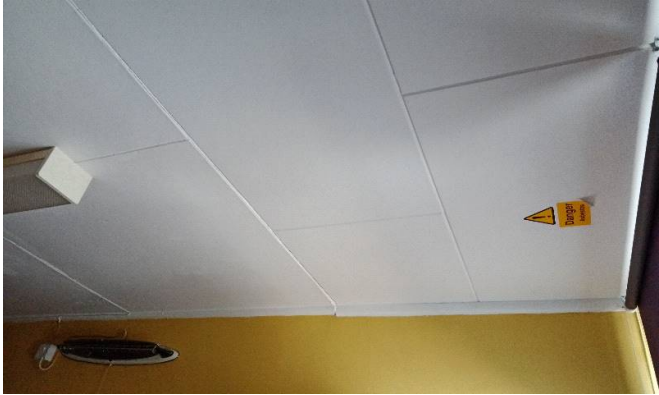
Sample Ref. No:	AC000125*
	Material Location:	Coated Fibreboard Ceiling
	Approx. Quantity:	15m ²
	Accessibility:	Occasionally likely to be disturbed
	Comments:	One small areas with flaking paint. Manageable condition. Do not disturb. Remove if affected by any proposed refurbishment works or if proven to be highly damaged.
	Sample Notes:	
Re-inspection notes:	Asbestos Yearly Re-inspection 24/25: 29/07/2024	
Recommendation:	No Attention Required (Inspect at intervals) – Good/reasonable condition and adequately surface treated	
Material Assessment Score (MAS)		Score
Product Type:	Asbestos Coated Fibreboard	2
Condition:	Low Damage	1
Treatment:	Sealed	1
Asbestos Type:	Chrysotile	1
Total:		5
Priority Assessment Score (PAS)		
Normal Occupant Activity Likelihood of Disturbance	Low disturbance	1
Location	Rooms up to 100m ²	2
Accessibility	Occasionally likely to be disturbed	1
Extent/Amount	10m ² - 50m ² or 10m - 50m pipe run	2

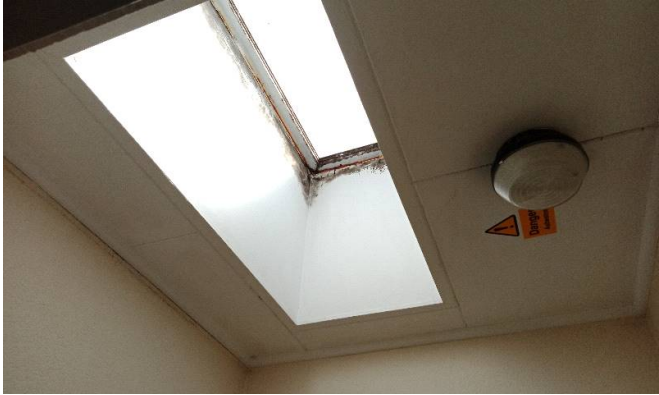
Sample Ref. No:	AS AC000125*
	Material Location:	Coated Fibreboard Ceiling
	Approx. Quantity:	2m ²
	Accessibility:	Occasionally likely to be disturbed
	Comments:	Small areas of peeling paint. Monitor condition for now. Remove if affected by proposed refurbishment works.
	Sample Notes:	
Re-inspection notes:	Asbestos Yearly Re-inspection 24/25: 29/07/2024	
Recommendation:	No Attention Required (Inspect at intervals) – Good/reasonable condition and adequately surface treated	
Material Assessment Score (MAS)		Score
Product Type:	Asbestos Coated Fibreboard	2
Condition:	Low Damage	1
Treatment:	Sealed	1
Asbestos Type:	Chrysotile	1
Total:		5
Priority Assessment Score (PAS)		
Normal Occupant Activity Likelihood of Disturbance	Rare disturbance	0
Location	Rooms up to 100m ²	2
Accessibility	Occasionally likely to be disturbed	1
Extent/Amount	<10m ² or <10m pipe run	1
Average Score		2
Human Exposure Potential

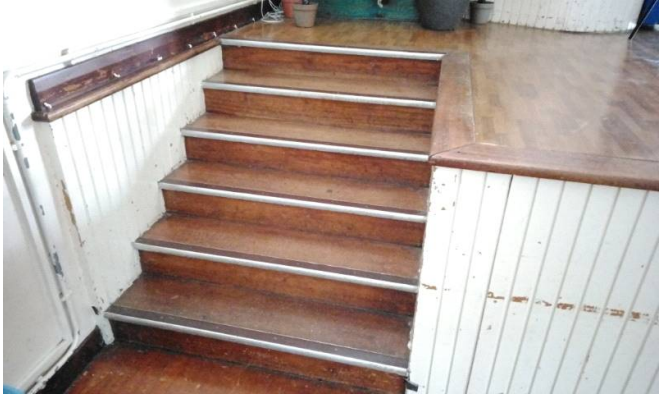
Sample Ref. No:	4153/1/0/017/10 {TPS000083}*
	Material Location:	Stair Nosing to either side of Hall
	Approx. Quantity:	1 per step
	Accessibility:	Routinely disturbed
	Comments:	Monitor condition. Remove if affected by proposed refurbishment works.
	Sample Notes:	
Re-inspection notes:	Asbestos Yearly Re-inspection 24/25: 29/07/2024	
Recommendation:	No Attention Required (Inspect at intervals) – Good/reasonable condition and adequately surface treated	
Material Assessment Score (MAS)		Score
Product Type:	Reinforced Composite	1
Condition:	Low Damage	1
Treatment:	Composite Material	0
Asbestos Type:	Chrysotile	1
Total:		3
Priority Assessment Score (PAS)		
Normal Occupant Activity	Low disturbance	1
Likelihood of Disturbance		
Location	Rooms up to 100m ²	2
Accessibility	Routinely disturbed	3
Extent/Amount	<10m ² or <10m pipe run	1
Average Score		2
Human Exposure Potential		
Number of Occupants	>10	3
Frequency of use of area	Daily	3

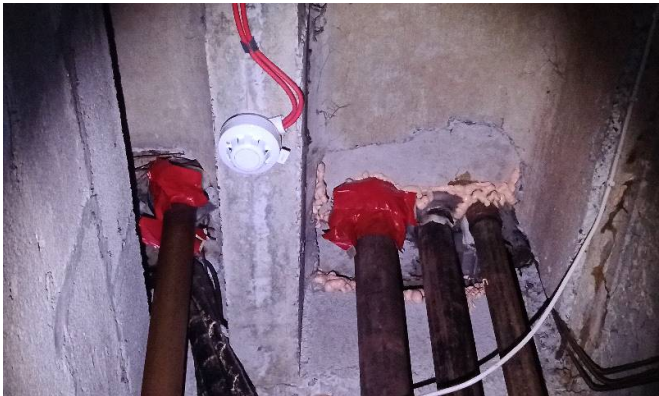
Sample Ref. No:	Presumed
	Material Location:	Asbestos Paper to top/bottom of pipework (also presumed within void duct under and above floor)
	Approx. Quantity:	0.25lm
	Accessibility:	Usually inaccessible or unlikely to be disturbed
	Comments:	Presumed to contain asbestos until otherwise proven. Top end of pipework is encapsulated, unable to verified bottom due to stored items (presumed debris and bottom end of pipe could have unsealed damaged asbestos paper below). Avoid disturbing rear floor area to Cleaners Cupboard - Encapsulation of bottom cavity recommended.
	Sample Notes:	
Re-inspection notes:	Asbestos Yearly Re-inspection 24/25: 29/07/2024 - Limited access due to stored items	
Recommendation:	Repair or Remove - Some damage present and/or vulnerable to further damage, but not causing an immediate hazard. Encapsulation or removal is strongly recommended.	
Material Assessment Score (MAS)		Score

Product Type:	Paper	2
Condition:	Medium Damage	2
Treatment:	Unsealed	2
Asbestos Type:	Chrysotile	1
Total:		7
Priority Assessment Score (PAS)		
Normal Occupant Activity	Rare disturbance	0
Likelihood of Disturbance		
Location	Confined spaces	3
Accessibility	Usually inaccessible or unlikely to be disturbed	0
Extent/Amount	Small amounts or items	0
Average Score		1
Human Exposure Potential		
Number of Occupants	1 to 3	1
Frequency of use of area	Daily	3
Average time area is in use	<1 hour - toilets	0
Average Score		2
Maintenance Activity		
Type of maintenance activity	Minor disturbance	0
Frequency of maintenance activity	Unlikely	0
Average Score		0
Total (Occupant Activity + 3 averages)		3
Total PAS & MAS		10

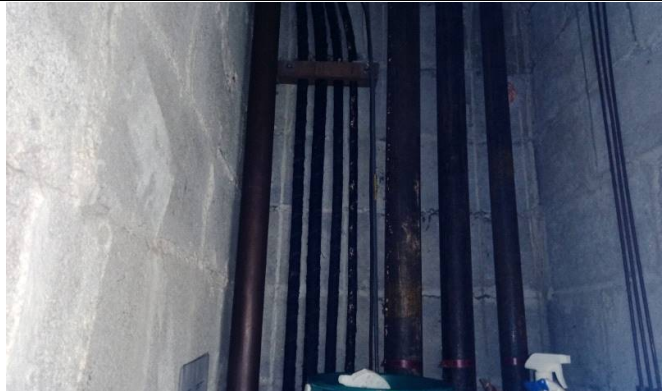
Sample Ref. No:	Presumed
	Material Location:	Woven Cable Wrap impregnated with Bitumen
	Approx. Quantity:	10m
	Accessibility:	Occasionally likely to be disturbed
	Comments:	Visual inspection to woven cable wrap. Presumed to contain asbestos until otherwise proven. Do not disturb.
	Sample Notes:	
Re-inspection notes:	Asbestos Yearly Re-inspection 24/25: 29/07/2024	
Recommendation:	No Attention Required (Inspect at intervals) – Good/reasonable condition and adequately surface treated	
Material Assessment Score (MAS)		Score
Product Type:	Textile	2
Condition:	Low Damage	1
Treatment:	Composite Material	0
Asbestos Type:	Chrysotile	1
Total:		4
Priority Assessment Score (PAS)		
Normal Occupant Activity Likelihood of Disturbance	Rare disturbance	0
Location	Confined spaces	3
Accessibility	Occasionally likely to be disturbed	1
Extent/Amount	<10m ² or <10m pipe run	1
Average Score		2
Human Exposure Potential

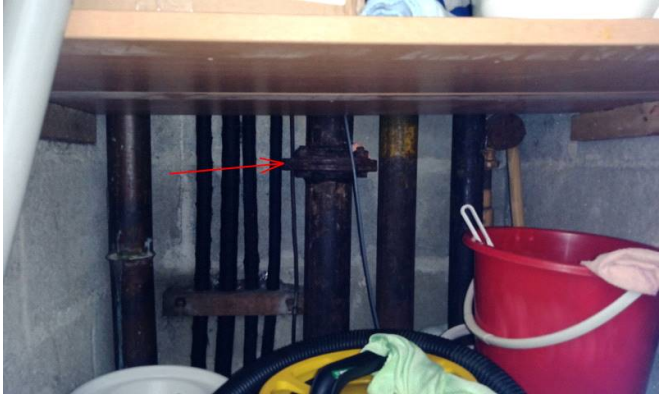
Sample Ref. No:	Presumed
	Material Location:	Gaskets to Pipework
	Approx. Quantity:	2no.
	Accessibility:	Usually inaccessible or unlikely to be disturbed
	Comments:	Visual inspection to pipework gasket. Presumed to contain asbestos until otherwise proven. Do not disturb. Remove if affected by any proposed refurbishment works or if proven to be damaged.
	Sample Notes:	
Re-inspection notes:	Asbestos Yearly Re-inspection 24/25: 29/07/2024	
Recommendation:	No Attention Required (Inspect at intervals) – Good/reasonable condition and adequately surface treated	
Material Assessment Score (MAS)		Score
Product Type:	Gasket	2
Condition:	Good Condition	0
Treatment:	Unsealed	1
Asbestos Type:	Chrysotile	1
Total:		4
Priority Assessment Score (PAS)		
Normal Occupant Activity Likelihood of Disturbance	Rare disturbance	0
Location	Confined spaces	3
Accessibility	Usually inaccessible or unlikely to be disturbed	0

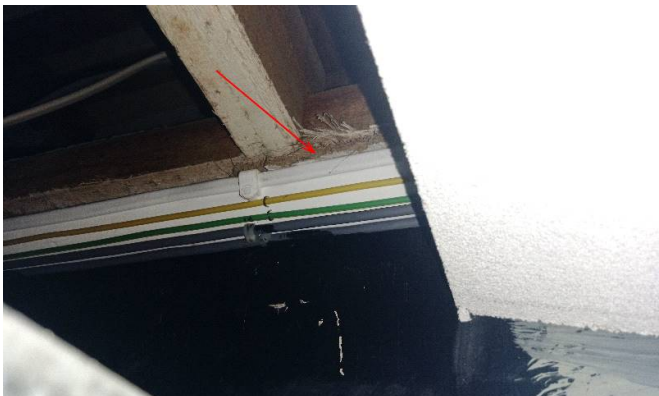
Sample Ref. No:	J134248 (TPS000084)*
	Material Location:	Coated Fibreboard Ceiling remains within Ceiling Void
	Approx. Quantity:	0.5m ²
	Accessibility:	Usually inaccessible or unlikely to be disturbed
	Comments:	Previous comments: Same as 4153/1/0/059/SP1- Left over section from previous July 2007 strip in former exam store that now forms part of classroom A1. Location indicated on Asbestos location floor plan. Located during fire alarm replacement/compartimentalisation project August 2018. Analysed & Encapsulated by Shield Environmental Ltd. 25/07/2023 Re-inspection: Nothing changed since 2022 according to Adam Brown (Wadebridge School Caretaker). Not accessed due to previously known damage. Only part encapsulated. Small area of exposed coated fibreboard still visible. Restrict access into the ceiling void and remove.
Sample Notes:		
Re-inspection notes:	Asbestos Yearly Re-inspection 24/25: 29/07/2024 - Carefully Inspected above suspended ceiling tiles and coated fibreboard debris are still found along the wall to Store 055 & Art A2 (061) - Surveyor recommends restricting access to ceiling void until complete removal of remaining asbestos coated fibreboard debris within ceiling void is done

Recommendation:	Urgent Removal – Poor condition, not adequately surface treated, vulnerable to damage. The area should be placed out of bounds until the work has been carried out.	
Material Assessment Score (MAS)		Score
Product Type:	Asbestos Coated Fibreboard	2
Condition:	High Damage	3
Treatment:	Unsealed	2
Asbestos Type:	Chrysotile	1
Total:		8
Priority Assessment Score (PAS)		
Normal Occupant Activity Likelihood of Disturbance	Low disturbance	1
Location	Rooms up to 100m ²	2
Accessibility	Usually inaccessible or unlikely to be disturbed	0
Extent/Amount	<10m ² or <10m pipe run	1
Average Score		1
Human Exposure Potential		
Number of Occupants	>10	3
Frequency of use of area	Daily	3
Average time area is in use	3 to 6 hours	2
Average Score		3
Maintenance Activity

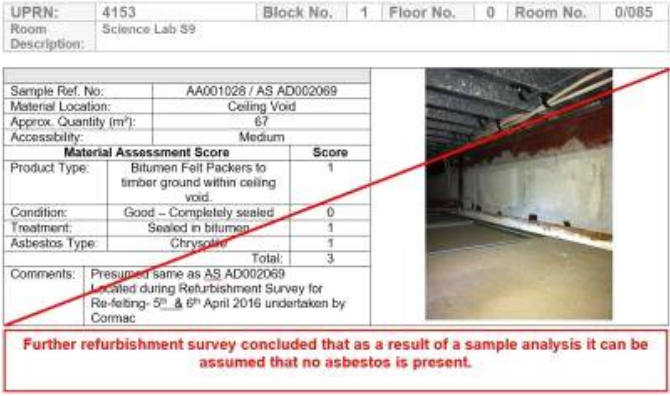
Sample Ref. No:	AA001028*
	Material Location:	Bitumen packer -
	Approx. Quantity:	Unknown
	Accessibility:	Usually inaccessible or unlikely to be disturbed
	Comments:	Presumed same AS AD002085. Located during Refurbishment Survey for Re-felting 5th & 6th April 2016 undertaken by Cormac. Also located during Refurbishment Survey for Fire Alarm Installation - 18th & 19th February 2019 undertaken by Allium. Further this refurb survey concluded, as a result of similar sample analysis it can be assumed that no asbestos is present. (material still present in ceiling void and not (Removed)
Sample Notes:		
Re-inspection notes:	Entry Removed: 25/07/2022	
Recommendation:	Removed	
Material Assessment Score (MAS)		Score
Product Type:	Removed	-
Condition:	N/A	-
Treatment:	N/A	-
Asbestos Type:	Removed	-
Total:		-
Priority Assessment Score (PAS)		
Normal Occupant Activity	N/A	-
Likelihood of Disturbance		
Location	N/A	-

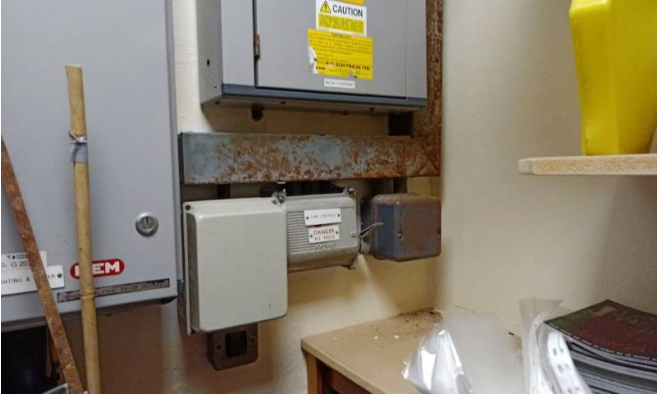
Sample Ref. No:	Presumed
	Material Location:	Flashguards within Electric Switchgear
	Approx. Quantity:	1no.
	Accessibility:	Usually inaccessible or unlikely to be disturbed
	Comments:	Presumed to contain asbestos until proven otherwise. Do not disturb. Remove if affected by any proposed refurbishment work.
	Sample Notes:	
Re-inspection notes:	Asbestos Yearly Re-inspection 24/25: 29/07/2024	
Recommendation:	No Attention Required (Inspect at intervals) – Good/reasonable condition and adequately surface treated	
Material Assessment Score (MAS)		Score
Product Type:	Flash Guards	2
Condition:	Good Condition	0
Treatment:	Sealed	2
Asbestos Type:	Chrysotile	1
Total:		5
Priority Assessment Score (PAS)		
Normal Occupant Activity Likelihood of Disturbance	Rare disturbance	0
Location	Rooms up to 100m ²	2
Accessibility	Usually inaccessible or unlikely to be disturbed	0
Extent/Amount	Small amounts or items	0
Average Score		1

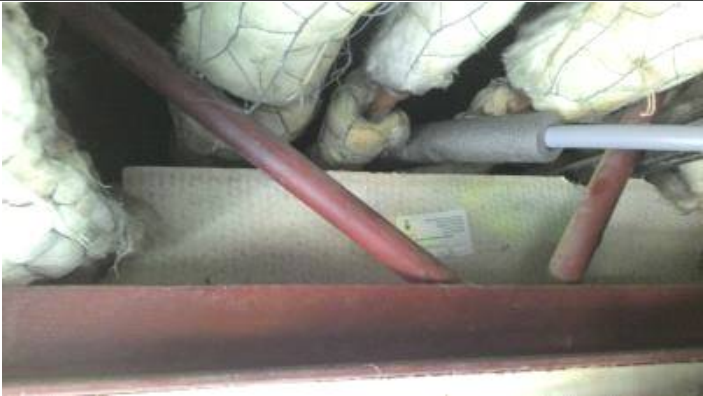
Sample Ref. No:	AD002071*
	Material Location:	AIB Boxing in void to Circ. (0/105)
	Approx. Quantity:	1.5m ²
	Accessibility:	Usually inaccessible or unlikely to be disturbed
	Comments:	Recorded as Removed on 28/07/2016 (Removed)
	Sample Notes:	
Re-inspection notes:	Asbestos Re-inspection 21-22: 2nd Visit - 25/07/2022	
Recommendation:	Removed	
Material Assessment Score (MAS)		Score
Product Type:	Removed	-
Condition:	N/A	-
Treatment:	N/A	-
Asbestos Type:	Removed	-
Total:		-
Priority Assessment Score (PAS)		
Normal Occupant Activity	N/A	-
Likelihood of Disturbance		
Location	N/A	-
Accessibility	Usually inaccessible or unlikely to be disturbed	-
Extent/Amount	N/A	-
Average Score		-
Human Exposure Potential		
Number of Occupants	N/A	-
Frequency of use of area	N/A	-
Average time area is in use	N/A	-
Average Score		-
Maintenance Activity		
Type of maintenance activity	N/A	-
Frequency of maintenance activity	N/A	-

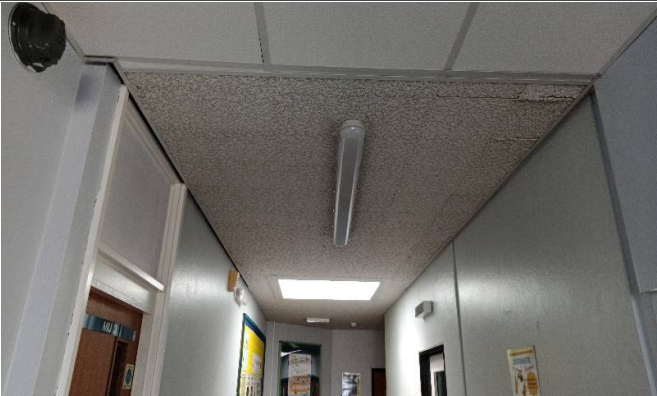
Sample Ref. No:	Inaccessible
	Material Location:	Ceiling Void above fixed Ceiling Tiles
	Approx. Quantity:	21m ²
	Accessibility:	N/A
	Comments:	Restricted Access above concealed fixed ceiling tiles. Presumed to contain asbestos until proven otherwise.
	Sample Notes:	
Re-inspection notes:	Asbestos Yearly Re-inspection 24/25: 29/07/2024	
Recommendation:	Inspection Required Prior to Disturbance – Appointed contractors carrying out routine maintenance work should be made aware that these areas were inaccessible at the time of the survey and that further investigation is required prior to disturbance of the material.	
Material Assessment Score (MAS)		Score
Product Type:	N/A	N/A
Condition:	N/A	N/A
Treatment:	N/A	N/A
Asbestos Type:	N/A	N/A
Total:		N/A
Priority Assessment Score (PAS)		
Normal Occupant Activity	N/A	-
Likelihood of Disturbance		
Location	N/A	N/A
Accessibility	N/A	N/A
Extent/Amount	N/A	N/A
Average Score		-

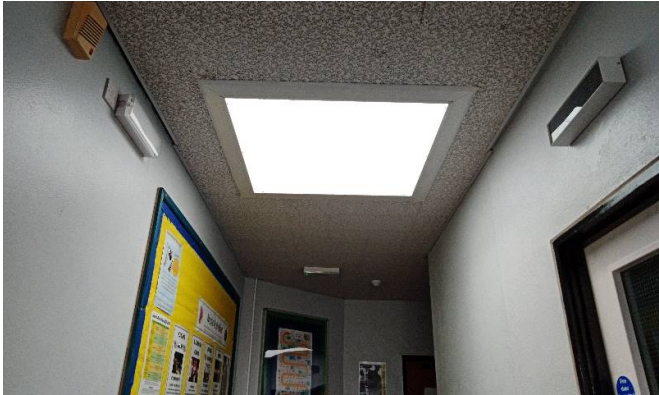
Sample Ref. No:	Inaccessible
	Material Location:	Rear of Skylight Lining Presumed to Contain Asbestos
	Approx. Quantity:	3m ²
	Accessibility:	N/A
	Comments:	Face is non asbestos Danotile plasterboard in good condition (completely sealed) with cover strips. Rear back presumed to contain asbestos until proven otherwise due to restricted access to original lining material of roof light as Refurbishment Survey for Fire Alarm Installation- 18th & 19th February 2019 undertaken by Allium. Exercise Caution.
Sample Notes:		
Re-inspection notes:	Asbestos Yearly Re-inspection 24/25: 29/07/2024	
Recommendation:	Inspection Required Prior to Disturbance – Appointed contractors carrying out routine maintenance work should be made aware that these areas were inaccessible at the time of the survey and that further investigation is required prior to disturbance of the material.	
Material Assessment Score (MAS)		Score

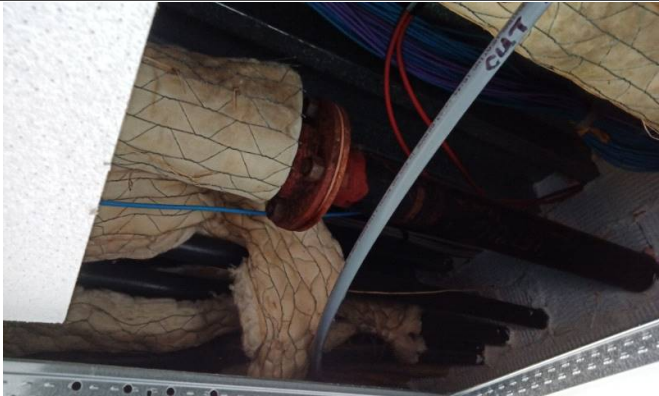
Sample Ref. No:	Presumed
	Material Location:	Gaskets to Pipework within Ceiling
	Approx. Quantity:	Throughout
	Accessibility:	Occasionally likely to be disturbed
	Comments:	Presumed to contain asbestos until proven otherwise. Do not disturb. Remove if affected by any proposed refurbishment works or if proven to be damaged.
	Sample Notes:	
Re-inspection notes:	Asbestos Yearly Re-inspection 23-24: 25/07/2023	
Recommendation:	No Attention Required (Inspect at intervals) – Good/reasonable condition and adequately surface treated	
Material Assessment Score (MAS)		Score
Product Type:	Gasket	2
Condition:	Low Damage	1
Treatment:	Unsealed	1
Asbestos Type:	Crocidolite (or unknown)	3
Total:		7
Priority Assessment Score (PAS)		
Normal Occupant Activity	Rare disturbance	0
Likelihood of Disturbance		
Location	Confined spaces	3
Accessibility	Occasionally likely to be disturbed	1
Extent/Amount	Small amounts or items	0

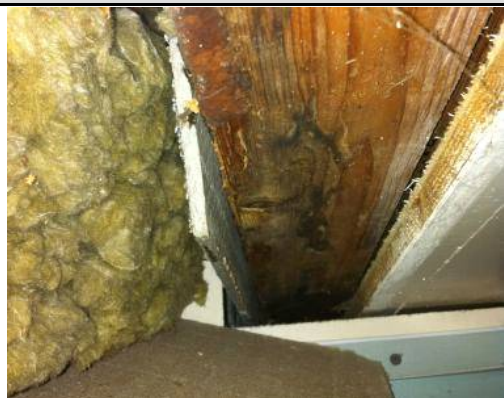
Sample Ref. No:	As 97323/MR/002 (CQ000712)*
	Material Location:	Cement Fascia within Ceiling Void (above door).
	Approx. Quantity:	1m ²
	Accessibility:	Usually inaccessible or unlikely to be disturbed
	Comments:	Nothing changed since last reinspection 2022 according to Adam Brown (Wadebridge School Caretaker). Not accessed as known to be damaged. Located during Re-felting July/August 2016. Limited access due to fibreglass insulation above NACTs. ACM broken in some areas. Exercise caution. Restrict access to the ceiling void until ACM has been repaired/removed.
Sample Notes:		
Re-inspection notes:	Asbestos Yearly Re-inspection 24/25: 29/07/2024	
Recommendation:	Repair or Remove – Some damage present and/or vulnerable to further damage, but not causing an immediate hazard. Encapsulation or removal is strongly recommended.	
Material Assessment Score (MAS)		Score
Product Type:	Asbestos Cement	1

Condition:	Medium Damage	2
Treatment:	Unsealed	1
Asbestos Type:	Crocidolite	3
Total:		7
Priority Assessment Score (PAS)		
Normal Occupant Activity	Low disturbance	1
Likelihood of Disturbance		
Location	Rooms up to 100m ²	2
Accessibility	Usually inaccessible or unlikely to be disturbed	0
Extent/Amount	<10m ² or <10m pipe run	1
Average Score		1
Human Exposure Potential		
Number of Occupants	>10	3
Frequency of use of area	Daily	3
Average time area is in use	3 to 6 hours	2
Average Score		3
Maintenance Activity		
Type of maintenance activity	Minor disturbance	0
Frequency of maintenance activity	Unlikely	0
Average Score		0
Total (Occupant Activity + 3 averages)		5
Total PAS & MAS		12

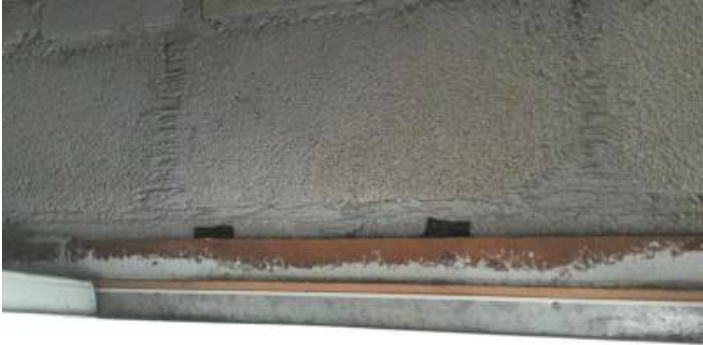
Sample Ref. No:	AD002069*
	Material Location:	Bitumen packers -
	Approx. Quantity:	Unknown
	Accessibility:	Usually inaccessible or unlikely to be disturbed
	Comments:	Located during Refurbishment Survey for Fire Alarm Installation - 18th & 19th February 2019 undertaken by Allium. No Asbestos Detected. Due to this refurb survey, it as been concluded as a result of similar sample analysis it can be assumed that no asbestos is present. (material still present in ceiling void and not (Removed)
	Sample Notes:	
Re-inspection notes:	Entry Removed: 25/07/2022	
Recommendation:	Removed	
Material Assessment Score (MAS)		Score
Product Type:	Removed	-
Condition:	N/A	-
Treatment:	N/A	-
Asbestos Type:	Removed	-
Total:		-
Priority Assessment Score (PAS)		
Normal Occupant Activity	N/A	-
Likelihood of Disturbance		
Location	N/A	-
Accessibility	Usually inaccessible or unlikely to be disturbed	-
Extent/Amount	N/A	-
Average Score		-

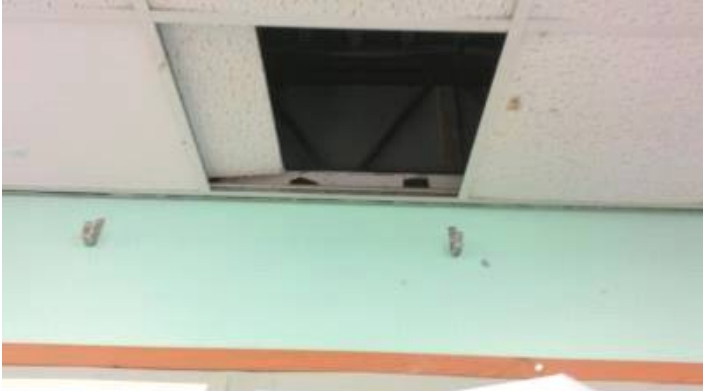
Sample Ref. No:	AD002085*
	Material Location:	Bitumen packers -
	Approx. Quantity:	Unknown
	Accessibility:	Usually inaccessible or unlikely to be disturbed
	Comments:	Located during Refurbishment Survey for Re-felting 5th & 6th April 2016 undertaken by Cormac. Also located during Refurbishment Survey for Fire Alarm Installation - 18th & 19th February 2019 undertaken by Allium. Due to this refurb survey, it as been concluded as a result of similar sample analysis it can be assumed that no asbestos is present. (material still present in ceiling void and not (Removed)
	Sample Notes:	
Re-inspection notes:	Entry Removed: 25/07/2022	
Recommendation:	Removed	
Material Assessment Score (MAS)		Score
Product Type:	Removed	-
Condition:	N/A	-
Treatment:	N/A	-
Asbestos Type:	Removed	-
Total:		-
Priority Assessment Score (PAS)		
Normal Occupant Activity	N/A	-
Likelihood of Disturbance		
Location	N/A	-
Accessibility	Usually inaccessible or unlikely to be disturbed	-

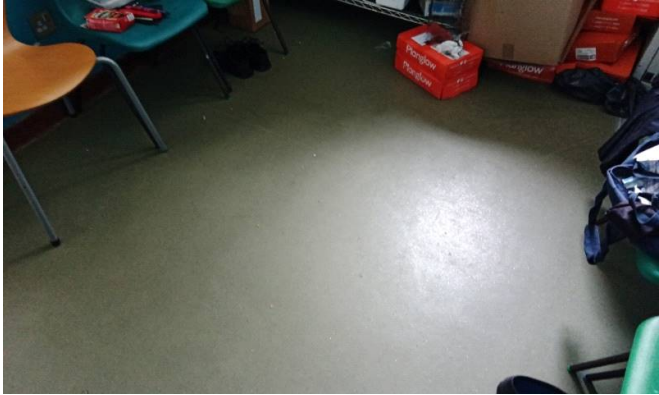
Sample Ref. No:	AG000013*
	Material Location:	Screed with Bitumen Residue under new Lino Flooring
	Approx. Quantity:	12m ²
	Accessibility:	Usually inaccessible or unlikely to be disturbed
	Comments:	Monitor condition. Remove if affected by proposed refurbishment works.
	Sample Notes:	
Re-inspection notes:	Asbestos Yearly Re-inspection 24/25: 29/07/2024	
Recommendation:	No Attention Required (Inspect at intervals) – Good/reasonable condition and adequately surface treated	
Material Assessment Score (MAS)		Score
Product Type:	Well Bound Material	1
Condition:	Good Condition	0
Treatment:	Composite Material	0
Asbestos Type:	Chrysotile	1
Total:		2
Priority Assessment Score (PAS)		
Normal Occupant Activity	Low disturbance	1
Likelihood of Disturbance		
Location	Rooms up to 100m ²	2
Accessibility	Usually inaccessible or unlikely to be disturbed	0
Extent/Amount	10m ² - 50m ² or 10m - 50m pipe run	2
Average Score		2

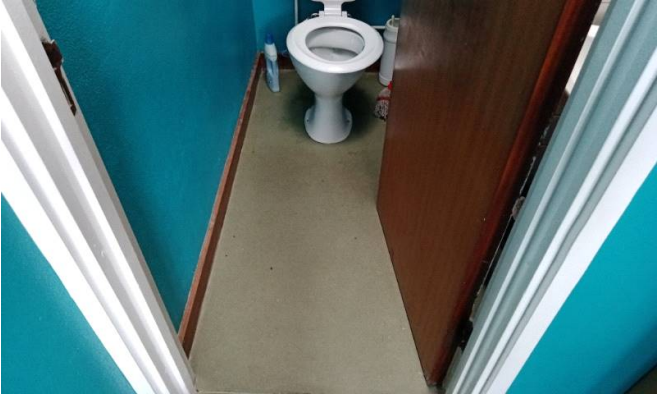
Sample Ref. No:	AS AG000013*
	Material Location:	Screed with Bitumen Residue under Lino Flooring
	Approx. Quantity:	3m ²
	Accessibility:	Usually inaccessible or unlikely to be disturbed
	Comments:	Monitor condition. Remove if affected by proposed refurbishment works.
	Sample Notes:	
Re-inspection notes:	Asbestos Yearly Re-inspection 24/25: 29/07/2024	
Recommendation:	No Attention Required (Inspect at intervals) – Good/reasonable condition and adequately surface treated	
Material Assessment Score (MAS)		Score
Product Type:	Well Bound Material	1
Condition:	Good Condition	0
Treatment:	Sealed	1
Asbestos Type:	Chrysotile	1
Total:		3
Priority Assessment Score (PAS)		
Normal Occupant Activity	Low disturbance	1
Likelihood of Disturbance		
Location	Rooms up to 100m ²	2
Accessibility	Usually inaccessible or unlikely to be disturbed	0
Extent/Amount	<10m ² or <10m pipe run	1
Average Score		1
Human Exposure Potential

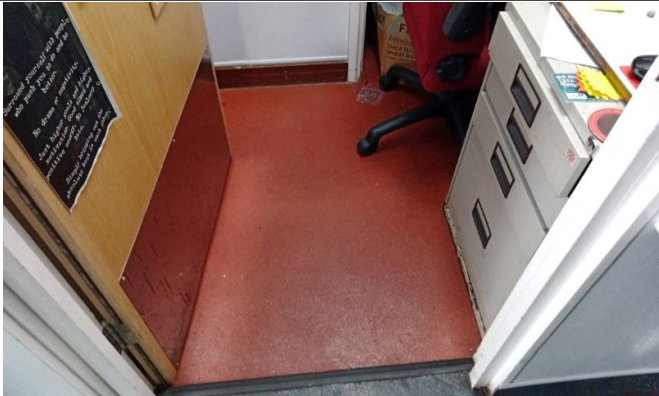
Sample Ref. No:	AD002089*
	Material Location:	Screed with Bitumen Residue under new Lino Flooring
	Approx. Quantity:	4m ²
	Accessibility:	Usually inaccessible or unlikely to be disturbed
	Comments:	Located during Refurbishment Survey for Re-felting - 5th & 6th April 2016 undertaken by Cormac. Further Refurb Survey taken on 21st December 2016. Monitor condition. Remove if affected by proposed refurbishment works.
	Sample Notes:	
Re-inspection notes:	Asbestos Yearly Re-inspection 24/25: 29/07/2024	
Recommendation:	No Attention Required (Inspect at intervals) – Good/reasonable condition and adequately surface treated	
Material Assessment Score (MAS)		Score
Product Type:	Well Bound Material	1
Condition:	Good Condition	0
Treatment:	Composite Material	0
Asbestos Type:	Chrysotile	1
Total:		2
Priority Assessment Score (PAS)		
Normal Occupant Activity	Low disturbance	1
Likelihood of Disturbance		
Location	Rooms up to 100m ²	2

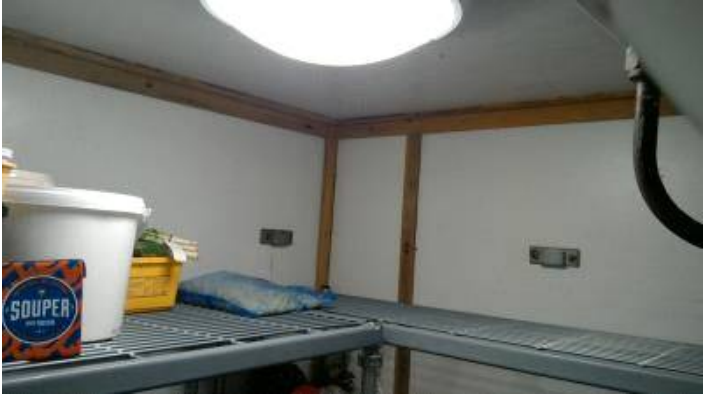
Sample Ref. No:	Presumed
	Material Location:	AC Lining to freezer
	Approx. Quantity:	14m ²
	Accessibility:	Easily disturbed
	Comments:	Not sampled to maintain integrity. Removed by Shield in 2019. Enabling work forming part of Kitchen and Dining Room Refurbishment (Removed)
	Sample Notes:	
Re-inspection notes:	Asbestos Re-inspection 21-22: 2nd Visit - 25/07/2022	
Recommendation:	Removed	
Material Assessment Score (MAS)		Score
Product Type:	Removed	-
Condition:	N/A	-
Treatment:	N/A	-
Asbestos Type:	Removed	-
Total:		-
Priority Assessment Score (PAS)		
Normal Occupant Activity	N/A	-
Likelihood of Disturbance		
Location	N/A	-
Accessibility	Easily disturbed	-
Extent/Amount	N/A	-
Average Score		-
Human Exposure Potential		
Number of Occupants	N/A	-
Frequency of use of area	N/A	-
Average time area is in use	N/A	-
Average Score		-
Maintenance Activity		
Type of maintenance activity	N/A	-
Frequency of maintenance activity	N/A	-

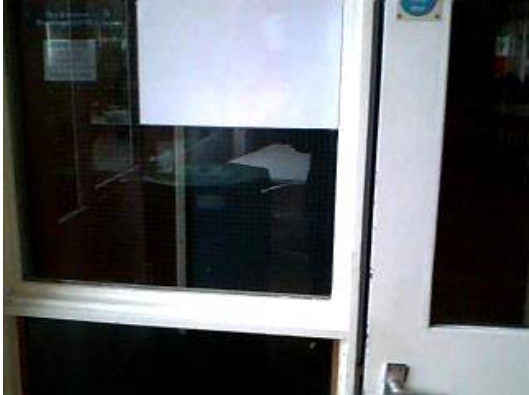
Sample Ref. No:	Presumed
	Material Location:	AIB Door Beading to fire screen on wood doors (to both sides) to Circulation
	Approx. Quantity:	14lm
	Accessibility:	Routinely disturbed
	Comments:	Previously sampled on sampling survey. Recorded as removed on 12/07/2018. (Removed)
	Sample Notes:	
Re-inspection notes:	Asbestos Re-inspection 21-22: 2nd Visit - 25/07/2022	
Recommendation:	Removed	
Material Assessment Score (MAS)		Score
Product Type:	Removed	-
Condition:	N/A	-
Treatment:	N/A	-
Asbestos Type:	Removed	-
Total:		-
Priority Assessment Score (PAS)		
Normal Occupant Activity	N/A	-
Likelihood of Disturbance		
Location	N/A	-
Accessibility	Routinely disturbed	-
Extent/Amount	N/A	-
Average Score		-
Human Exposure Potential		
Number of Occupants	N/A	-
Frequency of use of area	N/A	-
Average time area is in use	N/A	-
Average Score		-
Maintenance Activity		
Type of maintenance activity	N/A	-
Frequency of maintenance activity	N/A	-

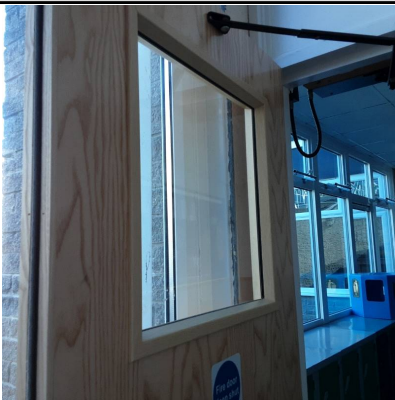
Sample Ref. No:	AA001026*
	Material Location:	AIB Beading to door glazing leading to Circ. (084)
	Approx. Quantity:	3lm
	Accessibility:	Easily disturbed
	Comments:	14/02/23 - Removed. (Removed)
	Sample Notes:	
Re-inspection notes:	Asbestos Re-inspection: 6 monthly inspection 14/02/23. Removed.	
Recommendation:	Removed	
Material Assessment Score (MAS)		Score
Product Type:	Removed	-
Condition:	N/A	-
Treatment:	N/A	-
Asbestos Type:	Removed	-
Total:		-
Priority Assessment Score (PAS)		
Normal Occupant Activity	N/A	-
Likelihood of Disturbance		
Location	N/A	-
Accessibility	Easily disturbed	-
Extent/Amount	N/A	-
Average Score		-
Human Exposure Potential		
Number of Occupants	N/A	-
Frequency of use of area	N/A	-
Average time area is in use	N/A	-
Average Score		-
Maintenance Activity		
Type of maintenance activity	N/A	-
Frequency of maintenance activity	N/A	-
Average Score		-
Total (Occupant Activity + 3 averages)		-

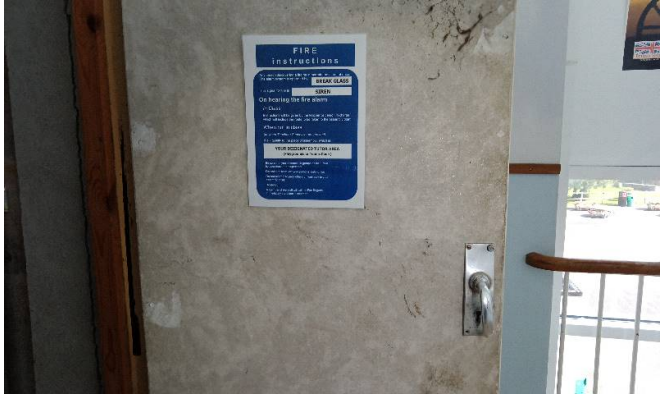
Sample Ref. No:	Presumed
	Material Location:	Insulation Board Backing Panel to Fire Door
	Approx. Quantity:	2m ²
	Accessibility:	Occasionally likely to be disturbed
	Comments:	Appears to be supalux board. Sampling exercise is recommended for reassurance. Backing panel in bare condition with some chipped/broken edges. Encapsulation/removal required. Keep door locked & do not disturb.
	Sample Notes:	
Re-inspection notes:	Asbestos Yearly Re-inspection 24/25: 29/07/2024	
Recommendation:	Repair or Remove – Some damage present and/or vulnerable to further damage, but not causing an immediate hazard. Encapsulation or removal is strongly recommended.	
Material Assessment Score (MAS)		Score
Product Type:	Asbestos Insulating Board	2
Condition:	Low Damage	1
Treatment:	Unsealed	2
Asbestos Type:	Amosite	2
Total:		7
Priority Assessment Score (PAS)		
Normal Occupant Activity	Rare disturbance	0
Likelihood of Disturbance

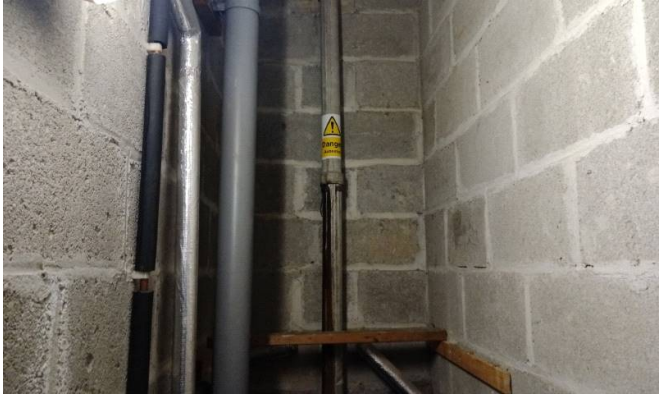
Sample Ref. No:	Presumed
	Material Location:	Cement Vent Pipe within Service Void
	Approx. Quantity:	10lm
	Accessibility:	Usually inaccessible or unlikely to be disturbed
	Comments:	Monitor condition. Remove if affected by proposed refurbishment works.
	Sample Notes:	
Re-inspection notes:	Asbestos Yearly Re-inspection 24/25: 29/07/2024	
Recommendation:	No Attention Required (Inspect at intervals) – Good/reasonable condition and adequately surface treated	
Material Assessment Score (MAS)		Score
Product Type:	Asbestos Cement	1
Condition:	Low Damage	1
Treatment:	Unsealed	1
Asbestos Type:	Crocidolite (or unknown)	3
Total:		6
Priority Assessment Score (PAS)		
Normal Occupant Activity Likelihood of Disturbance	Rare disturbance	0
Location	Confined spaces	3
Accessibility	Usually inaccessible or unlikely to be disturbed	0
Extent/Amount	<10m ² or <10m pipe run	1
Average Score		2
Human Exposure Potential		
Number of Occupants	1 to 3	1

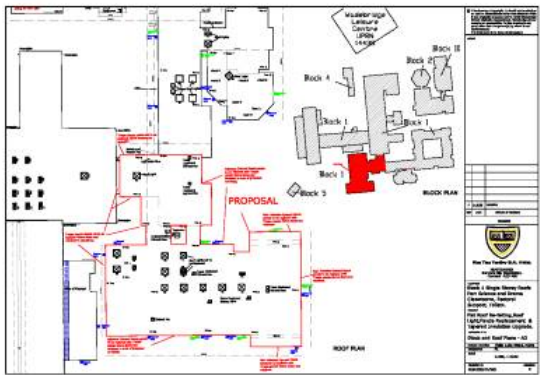
Sample Ref. No:	AD002077*
	Material Location:	Roof Felt to Bottom Layer
	Approx. Quantity:	903m ²
	Accessibility:	Usually inaccessible or unlikely to be disturbed
	Comments:	Same as AD002079, AD002081 & BS00563. Bottom layer of roof felt to 1972 & 1977 Extensions under 1987, 1990's, 2016 & 2017 overlays. Good sealed condition.
	Sample Notes:	
Re-inspection notes:	Asbestos Yearly Re-inspection 24/25: 29/07/2024	
Recommendation:	No Attention Required (Inspect at intervals) – Good/reasonable condition and adequately surface treated	
Material Assessment Score (MAS)		Score
Product Type:	Well Bound Material	1
Condition:	Low Damage	1
Treatment:	Composite Material	0
Asbestos Type:	Chrysotile	1
Total:		3
Priority Assessment Score (PAS)		
Normal Occupant Activity Likelihood of Disturbance	Rare disturbance	0
Location	External	0
Accessibility	Usually inaccessible or unlikely to be disturbed	0
Extent/Amount	>50m ² or >50m pipe run	3

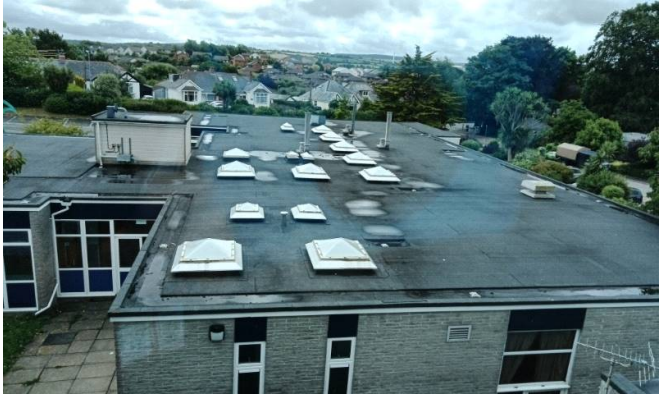
Sample Ref. No:	AD002079*
	Material Location:	Roof Felt to Bottom Layer
	Approx. Quantity:	-m ²
	Accessibility:	Usually inaccessible or unlikely to be disturbed
	Comments:	Same as AD002077, AD002081 & BS00563. Bottom layer of roof felt to 1972 & 1977 Extensions under 1987, 1990's, 2016 & 2017 overlays.
	Sample Notes:	
Re-inspection notes:	Asbestos Yearly Re-inspection 24/25: 29/07/2024	
Recommendation:	No Attention Required (Inspect at intervals) – Good/reasonable condition and adequately surface treated	
Material Assessment Score (MAS)		Score
Product Type:	Well Bound Material	1
Condition:	Low Damage	1
Treatment:	Composite Material	0
Asbestos Type:	Chrysotile	1
Total:		3
Priority Assessment Score (PAS)		
Normal Occupant Activity Likelihood of Disturbance	Rare disturbance	0
Location	External	0
Accessibility	Usually inaccessible or unlikely to be disturbed	0
Extent/Amount	>50m ² or >50m pipe run	3
