Wadebridge School

ASBESTOS MANAGEMENT POLICY September 2024

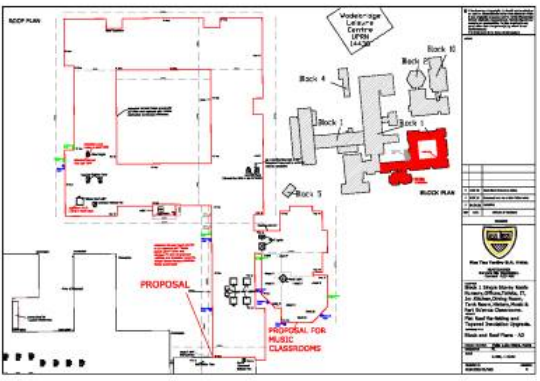
Sample Ref. No:	AD002081*
	Material Location:	Roof Felt To Bottom Layer
	Approx. Quantity:	1474m ²
	Accessibility:	Usually inaccessible or unlikely to be disturbed
	Comments:	Same as AD002077 , AD002079 & BS00563. Bottom layer of roof felt to 1972 & 1977 Extensions under 1987, 1990's , 2016 & 2017 overlays. Good sealed condition.
	Sample Notes:	
Re-inspection notes:	Asbestos Yearly Re-inspection 24/25: 29/07/2024	
Recommendation:	No Attention Required (Inspect at intervals) – Good/reasonable condition and adequately surface treated	
Material Assessment Score (MAS)		Score
Product Type:	Well Bound Material	1
Condition:	Low Damage	1
Treatment:	Composite Material	0
Asbestos Type:	Chrysotile	1
Total:		3
Priority Assessment Score (PAS)		
Normal Occupant Activity Likelihood of Disturbance	Rare disturbance	0
Location	External	0
Accessibility	Usually inaccessible or unlikely to be disturbed	0
Extent/Amount	>50m ² or >50m pipe run	3

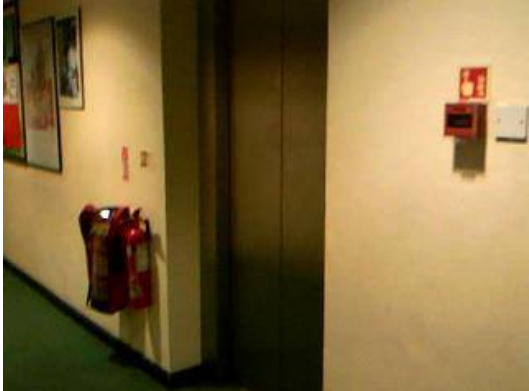
Sample Ref. No:	Inaccessible
	Material Location:	Inaccessible
	Approx. Quantity:	N/A
	Accessibility:	N/A
	Comments:	Gain access & survey prior to any disturbance.
	Sample Notes:	
Re-inspection notes:	Asbestos Yearly Re-inspection 23-24: 25/07/2023	
Recommendation:	Inspection Required Prior to Disturbance – Appointed contractors carrying out routine maintenance work should be made aware that these areas were inaccessible at the time of the survey and that further investigation is required prior to disturbance of the material.	
Material Assessment Score (MAS)		Score
Product Type:	N/A	N/A
Condition:	N/A	N/A
Treatment:	N/A	N/A
Asbestos Type:	N/A	N/A
Total:		N/A
Priority Assessment Score (PAS)		
Normal Occupant Activity	N/A	-
Likelihood of Disturbance		
Location	N/A	N/A
Accessibility	N/A	N/A
Extent/Amount	N/A	N/A
Average Score		-
Human Exposure Potential		
Number of Occupants	N/A	N/A
Frequency of use of area	N/A	N/A

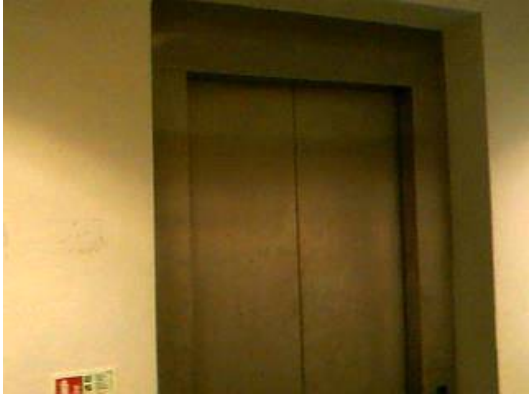
Sample Ref. No:	Inaccessible
	Material Location:	Inaccessible
	Approx. Quantity:	N/A
	Accessibility:	N/A
	Comments:	Gain access & survey prior to any disturbance.
	Sample Notes:	
Re-inspection notes:	Asbestos Yearly Re-inspection 23-24: 25/07/2023	
Recommendation:	Inspection Required Prior to Disturbance – Appointed contractors carrying out routine maintenance work should be made aware that these areas were inaccessible at the time of the survey and that further investigation is required prior to disturbance of the material.	
Material Assessment Score (MAS)		Score
Product Type:	N/A	N/A
Condition:	N/A	N/A
Treatment:	N/A	N/A
Asbestos Type:	N/A	N/A
Total:		N/A
Priority Assessment Score (PAS)		
Normal Occupant Activity	N/A	-
Likelihood of Disturbance		
Location	N/A	N/A
Accessibility	N/A	N/A
Extent/Amount	N/A	N/A
Average Score		-
Human Exposure Potential		
Number of Occupants	N/A	N/A
Frequency of use of area	N/A	N/A

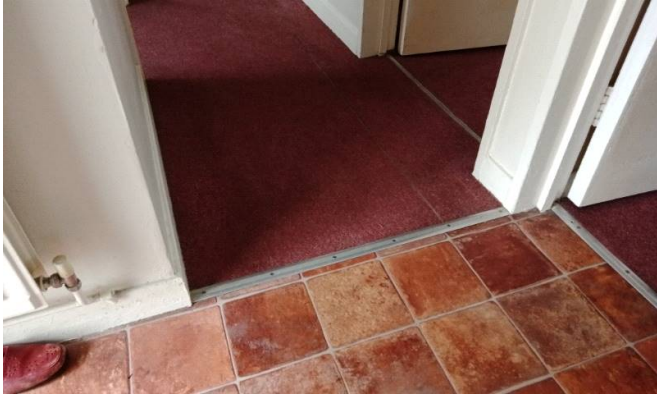
Sample Ref. No:	69765 / 003 (TPS000085)*
	Material Location:	VFTs & Adhesive below modern Vinyl/Carpet floor
	Approx. Quantity:	6m ²
	Accessibility:	Usually inaccessible or unlikely to be disturbed
	Comments:	Monitor condition. Remove if affected by proposed refurbishment works.
	Sample Notes:	
Re-inspection notes:	Asbestos Yearly Re-inspection 24/25: 29/07/2024 (Tenant feeling unwell - internal rooms not accessed)	
Recommendation:	No Attention Required (Inspect at intervals) – Good/reasonable condition and adequately surface treated	
Material Assessment Score (MAS)		Score
Product Type:	Vinyl Floor Tile & Adhesive	1
Condition:	Good Condition	0
Treatment:	Composite Material	0
Asbestos Type:	Chrysotile	1
Total:		2
Priority Assessment Score (PAS)		
Normal Occupant Activity	Low disturbance	1
Likelihood of Disturbance		
Location	Rooms up to 100m ²	2
Accessibility	Usually inaccessible or unlikely to be disturbed	0

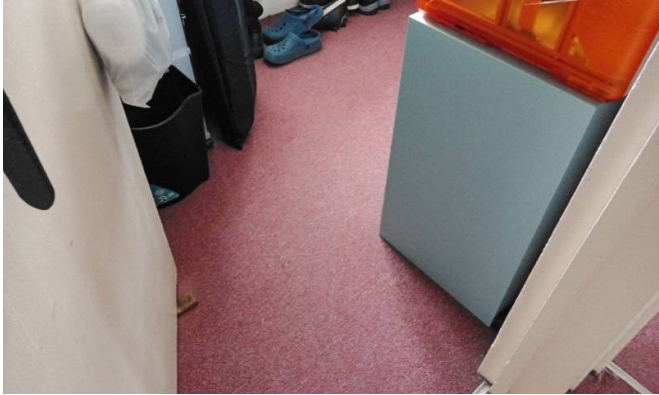
Sample Ref. No:	AS 69765 / 003 {TPS000085}*
	Material Location:	VFTs & Adhesive below Carpet
	Approx. Quantity:	7m ²
	Accessibility:	Usually inaccessible or unlikely to be disturbed
	Comments:	Monitor condition. Remove if affected by proposed refurbishment works.
	Sample Notes:	
Re-inspection notes:	Asbestos Yearly Re-inspection 24/25: 29/07/2024 (Tenant feeling unwell - internal rooms not accessed)	
Recommendation:	No Attention Required (Inspect at intervals) – Good/reasonable condition and adequately surface treated	
Material Assessment Score (MAS)		Score
Product Type:	Vinyl Floor Tile & Adhesive	1
Condition:	Good Condition	0
Treatment:	Composite Material	0
Asbestos Type:	Chrysotile	1
Total:		2
Priority Assessment Score (PAS)		
Normal Occupant Activity	Low disturbance	1
Likelihood of Disturbance		
Location	Rooms up to 100m ²	2
Accessibility	Usually inaccessible or unlikely to be disturbed	0
Extent/Amount	<10m ² or <10m pipe run	1

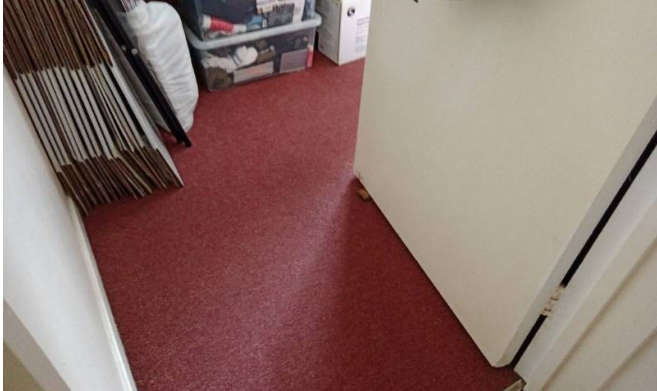
Sample Ref. No:	AS 69765 / 003 {TPS000085}*
	Material Location:	VFTs & Adhesive below Carpet
	Approx. Quantity:	11m ²
	Accessibility:	Usually inaccessible or unlikely to be disturbed
	Comments:	Monitor condition. Remove if affected by proposed refurbishment works.
	Sample Notes:	
Re-inspection notes:	Asbestos Yearly Re-inspection 24/25: 29/07/2024 (Tenant feeling unwell - internal rooms not accessed)	
Recommendation:	No Attention Required (Inspect at intervals) – Good/reasonable condition and adequately surface treated	
Material Assessment Score (MAS)		Score
Product Type:	Vinyl Floor Tile & Adhesive	1
Condition:	Good Condition	0
Treatment:	Composite Material	0
Asbestos Type:	Chrysotile	1
Total:		2
Priority Assessment Score (PAS)		
Normal Occupant Activity	Low disturbance	1
Likelihood of Disturbance		
Location	Rooms up to 100m ²	2
Accessibility	Usually inaccessible or unlikely to be disturbed	0
Extent/Amount	10m ² - 50m ² or 10m - 50m pipe run	2

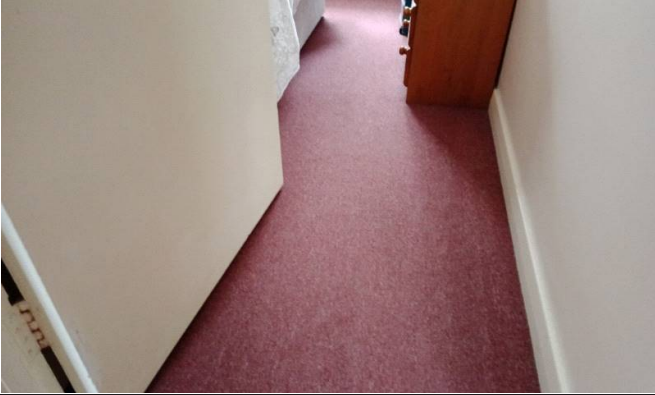
Sample Ref. No:	AS 69765 / 003 {TPS000085}*
	Material Location:	VFTs & Adhesive below Carpet
	Approx. Quantity:	12m ²
	Accessibility:	Usually inaccessible or unlikely to be disturbed
	Comments:	Monitor condition. Remove if affected by proposed refurbishment works.
	Sample Notes:	
Re-inspection notes:	Asbestos Yearly Re-inspection 24/25: 29/07/2024 (Tenant feeling unwell - internal rooms not accessed)	
Recommendation:	No Attention Required (Inspect at intervals) – Good/reasonable condition and adequately surface treated	
Material Assessment Score (MAS)		Score
Product Type:	Vinyl Floor Tile & Adhesive	1
Condition:	Good Condition	0
Treatment:	Composite Material	0
Asbestos Type:	Chrysotile	1
Total:		2
Priority Assessment Score (PAS)		
Normal Occupant Activity	Low disturbance	1
Likelihood of Disturbance		
Location	Rooms up to 100m ²	2
Accessibility	Usually inaccessible or unlikely to be disturbed	0
Extent/Amount	10m ² - 50m ² or 10m - 50m pipe run	2

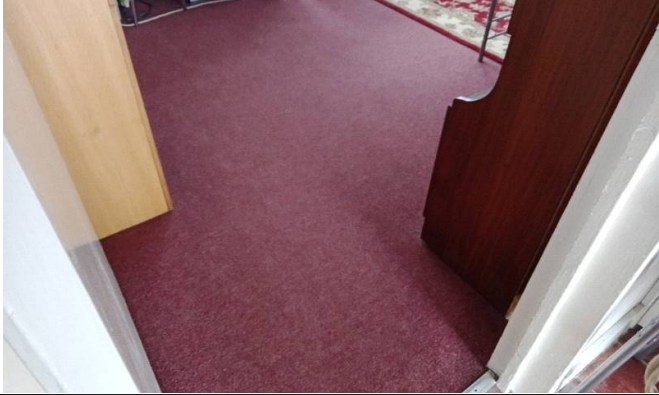
Sample Ref. No:	AS 69765 / 003 {TPS000085}*
	Material Location:	VFTs & Adhesive below Carpet
	Approx. Quantity:	20m ²
	Accessibility:	Usually inaccessible or unlikely to be disturbed
	Comments:	Monitor condition. Remove if affected by proposed refurbishment works.
	Sample Notes:	
Re-inspection notes:	Asbestos Yearly Re-inspection 24/25: 29/07/2024 (Tenant feeling unwell - internal rooms not accessed)	
Recommendation:	No Attention Required (Inspect at intervals) – Good/reasonable condition and adequately surface treated	
Material Assessment Score (MAS)		Score
Product Type:	Vinyl Floor Tile & Adhesive	1
Condition:	Low Damage	1
Treatment:	Composite Material	0
Asbestos Type:	Chrysotile	1
Total:		3
Priority Assessment Score (PAS)		
Normal Occupant Activity	Low disturbance	1
Likelihood of Disturbance		
Location	Rooms up to 100m ²	2
Accessibility	Usually inaccessible or unlikely to be disturbed	0
Extent/Amount	10m ² - 50m ² or 10m - 50m pipe run	2

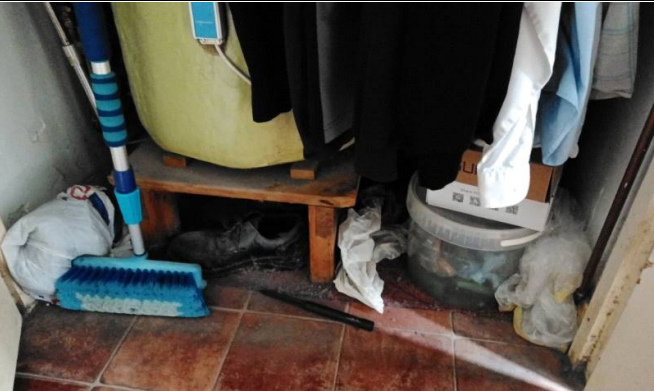
Sample Ref. No:	AS 69765 / 003 {TPS000085}*
	Material Location:	VFTs & Adhesive below Carpet
	Approx. Quantity:	1.5m ²
	Accessibility:	Usually inaccessible or unlikely to be disturbed
	Comments:	Monitor condition. Remove if affected by proposed refurbishment works.
	Sample Notes:	
Re-inspection notes:	Asbestos Yearly Re-inspection 24/25: 29/07/2024 (Tenant feeling unwell - internal rooms not accessed)	
Recommendation:	No Attention Required (Inspect at intervals) – Good/reasonable condition and adequately surface treated	
Material Assessment Score (MAS)		Score
Product Type:	Vinyl Floor Tile & Adhesive	1
Condition:	Good Condition	0
Treatment:	Composite Material	0
Asbestos Type:	Chrysotile	1
Total:		2
Priority Assessment Score (PAS)		
Normal Occupant Activity	Rare disturbance	0
Likelihood of Disturbance		
Location	Rooms up to 100m ²	2
Accessibility	Usually inaccessible or unlikely to be disturbed	0

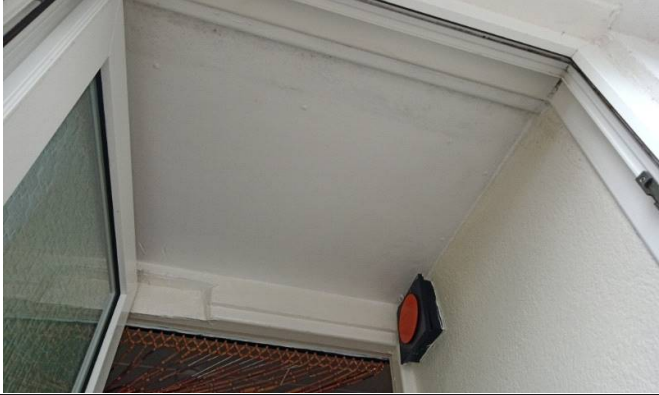
Sample Ref. No:	69765/005 {TPS000086}*
	Material Location:	Cement Ceiling Panel to Porch
	Approx. Quantity:	1m ²
	Accessibility:	Occasionally likely to be disturbed
	Comments:	Unable to access. Monitor condition if in good condition. Repair/removal recommended if damaged or prior to any disturbance.
	Sample Notes:	
Re-inspection notes:	Asbestos Yearly Re-inspection 24/25: 29/07/2024 (Tenant feeling unwell - internal rooms not accessed)	
Recommendation:	Inspection Required Prior to Disturbance – Appointed contractors carrying out routine maintenance work should be made aware that these areas were inaccessible at the time of the survey and that further investigation is required prior to disturbance of the material.	
Material Assessment Score (MAS)		Score
Product Type:	Asbestos Cement	1
Condition:	Good Condition	0
Treatment:	Sealed	1
Asbestos Type:	Chrysotile	1
Total:		3
Priority Assessment Score (PAS)
