Wadebridge School

ASBESTOS MANAGEMENT POLICY September 2024

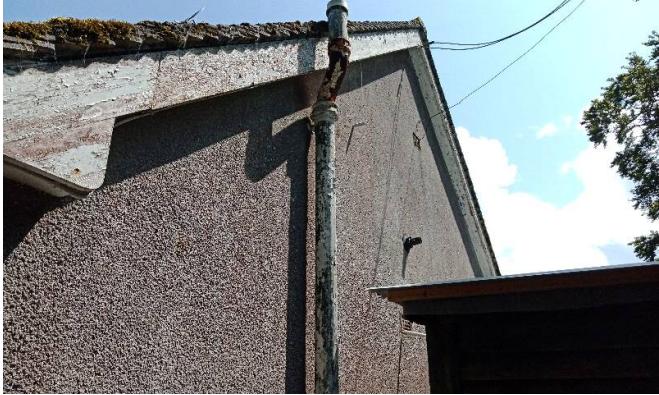
Sample Ref. No:	69765/006 {TPS000087}*
	Material Location:	Cement Soil Vent Pipe
	Approx. Quantity:	2.5lm
	Accessibility:	Easily disturbed
	Comments:	Top bit appears to be made of iron cast made. Flaking paint to the full pipe length. Monitor condition. Remove if affected by proposed refurbishment works.
	Sample Notes:	
Re-inspection notes:	Asbestos Yearly Re-inspection 24/25: 29/07/2024 (Tenant feeling unwell - rear garden not accessed - fenced off)	
Recommendation:	No Attention Required (Inspect at intervals) – Good/reasonable condition and adequately surface treated	
Material Assessment Score (MAS)		Score
Product Type:	Asbestos Cement	1
Condition:	Low Damage	1
Treatment:	Unsealed	1
Asbestos Type:	Chrysotile	1
Total:		4
Priority Assessment Score (PAS)		
Normal Occupant Activity	Low disturbance	1
Likelihood of Disturbance		
Location	External	0
Accessibility	Easily disturbed	2
Extent/Amount	<10m ² or <10m pipe run	1

Average Score		1
Human Exposure Potential		
Number of Occupants	None	0
Frequency of use of area	Infrequent	0
Average time area is in use	<1 hour - toilets	0
Average Score		0
Maintenance Activity		
Type of maintenance activity	Minor disturbance	0
Frequency of maintenance activity	Unlikely	0
Average Score		0
Total (Occupant Activity + 3 averages)		2
Total PAS & MAS		6

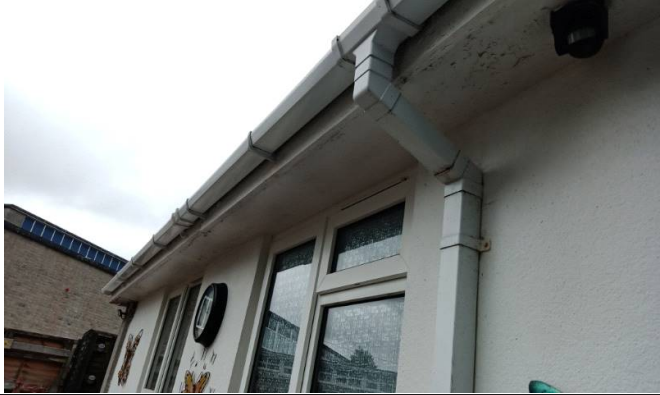
Sample Ref. No:	69765/007 {TPS000088}*
	Material Location:	Cement soffits around Building
	Approx. Quantity:	35lm
	Accessibility:	Occasionally likely to be disturbed
	Comments:	Flaking paint to the cement soffits. Monitor condition. Remove if affected by proposed refurbishment works.
	Sample Notes:	
Re-inspection notes:	Asbestos Yearly Re-inspection 24/25: 29/07/2024	
Recommendation:	Repair or Remove – Some damage present and/or vulnerable to further damage, but not causing an immediate hazard. Encapsulation or removal is strongly recommended.	
Material Assessment Score (MAS)		Score
Product Type:	Asbestos Cement	1
Condition:	Low Damage	1
Treatment:	Unsealed	1
Asbestos Type:	Chrysotile	1
Total:		4
Priority Assessment Score (PAS)		
Normal Occupant Activity	Low disturbance	1
Likelihood of Disturbance		
Location	External	0
Accessibility	Occasionally likely to be disturbed	1
Extent/Amount	10m ² - 50m ² or 10m - 50m pipe run	2

Average Score	1
Human Exposure Potential		
Number of Occupants	1 to 3	1
Frequency of use of area	Daily	3
Average time area is in use	<1 hour - toilets	0
	Average Score	2
Maintenance Activity		
Type of maintenance activity	Low disturbance	1
Frequency of maintenance activity	<1 per year	1
	Average Score	1
	Total (Occupant Activity + 3 averages)	5
	Total PAS & MAS	9
